WASHINGTON UNION STATION ROSTRAL COLUMNS RESTORATION

Aeon is currently leading a team to restore two sets of large historic ornamental cast-iron columns, lamp posts, and granite balustrades located in Columbus Plaza directly in front of Union Station in Washington, D.C. Union Station was designed by Daniel Burnham and erected in 1908. The Plaza was constructed in 1912. The ornamental ironwork was fabricated by the Chicago Ornamental Iron Company. The columns are known as "Rostral Columns," which in antiquity, were used to celebrate great naval accomplishments and which incorporated the bronze ram or hull ornament from vanquished ships.

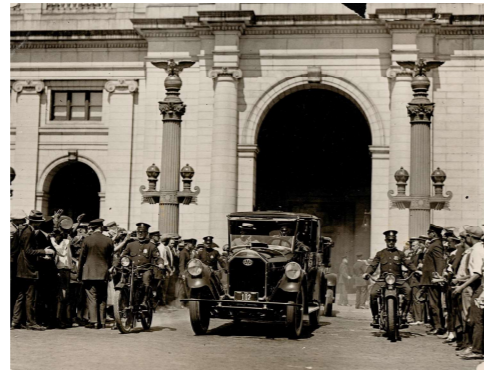
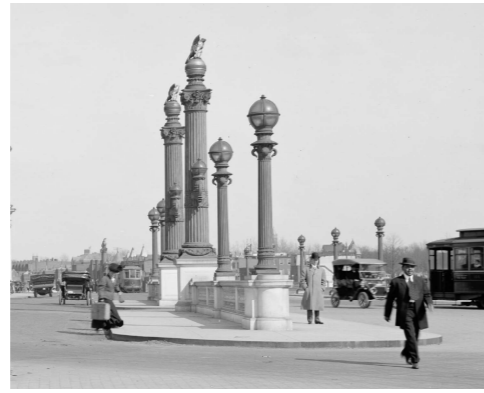
HISTORICAL ANALYSIS

Review of archival records included searching for historic images that showed the rostral columns, original construction drawings, and past studies and project records. Only a handful of images were located that showed the columns in any great detail. The upper image shows a motorcade progressing through the columns c.1924. The lower image shows the columns flanked by two lamp posts instead of the single fixtures visible today c.1918. Analysis of these photos showed the changes to the balustrade over time.

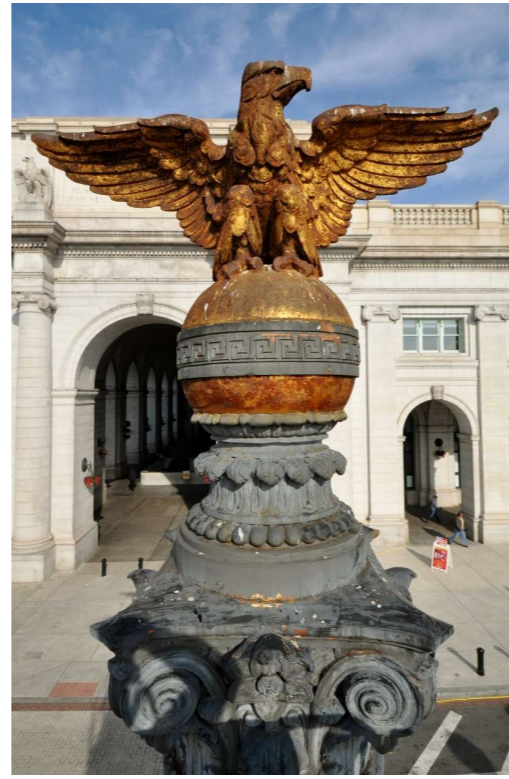
PHYSICAL ANALYSIS

The columns and lampposts were surveyed in detail from a self-propelled manlift. All surfaces were photo-documented and all visible fastener locations mapped out. Casting interiors were also photographed with a hand-held camera as well as a mounted GoPro camera with an independent LED light array to see into concealed areas. Columns and lamp posts were also laser scanned using a FARO Focus 3D Laser Scanner for general layout and a handheld Artec EVA scattered light 3D scanner for close in details to create accurate CAD drawings.

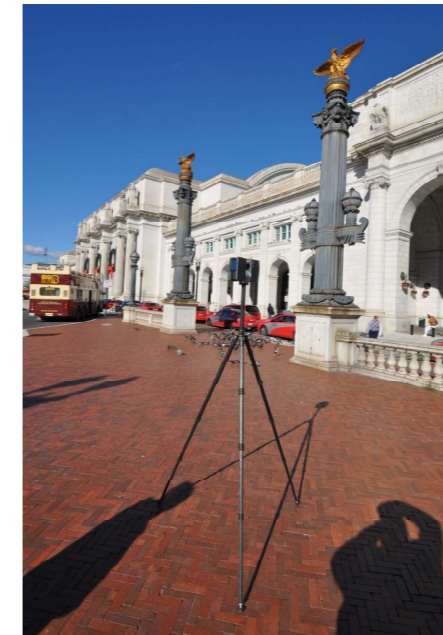
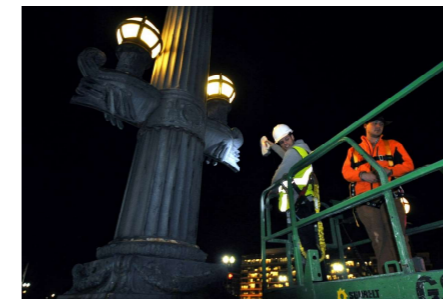
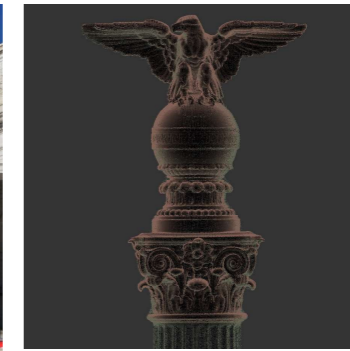
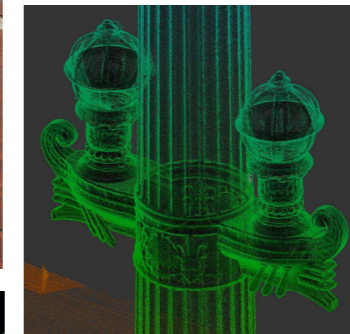
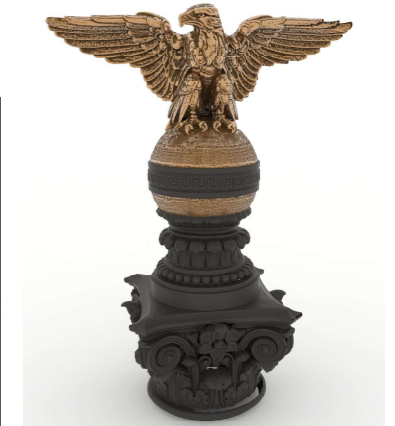
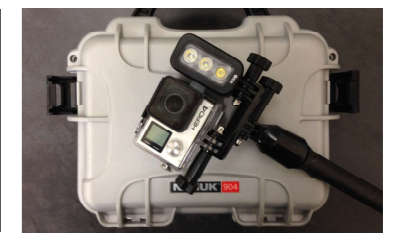
LASER SCANNING

The first stage of the project involved digital laser scanning of the columns and modeling to create CAD base drawings.

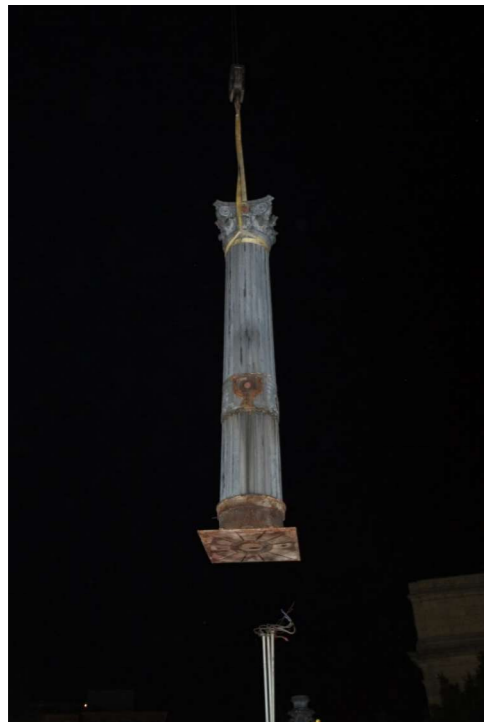
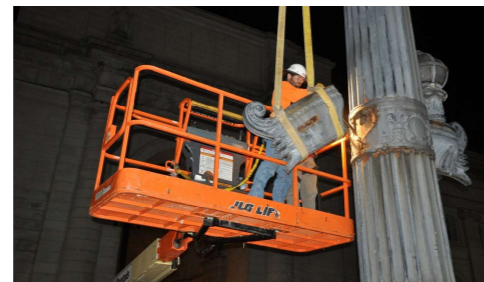
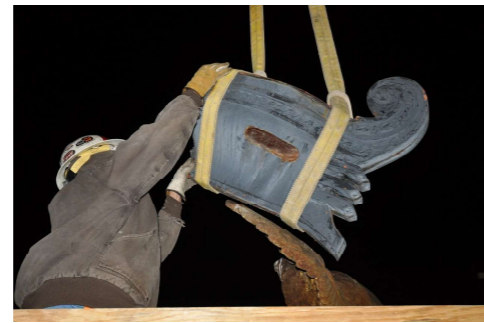
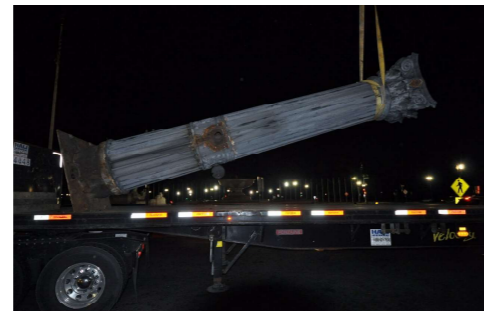
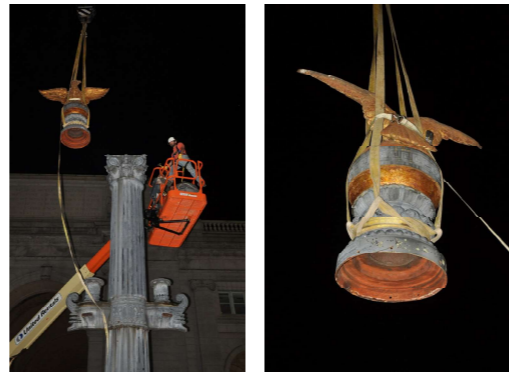
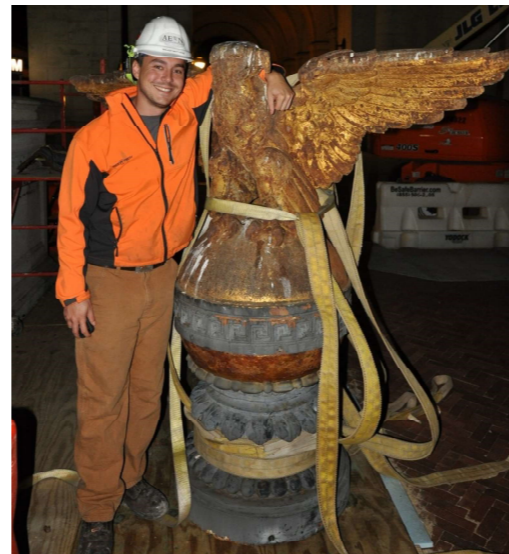
DISASSEMBLY & CRANE PICKS

The first phase of construction involves careful disassembly and dismantling of the primary cast iron components. This started with the globes, sconce decks, and rostrum. This was followed by the eagle and globe assembly which weighs about 800 lbs. The column shaft is made up of five major components that were all lifted together as one. This pick was about 7,500 lbs. The lampposts were cut free and lifted last. All elements were laid on a flat bed truck with smaller elements crated and secured and driven to Alexander City, Alabama.

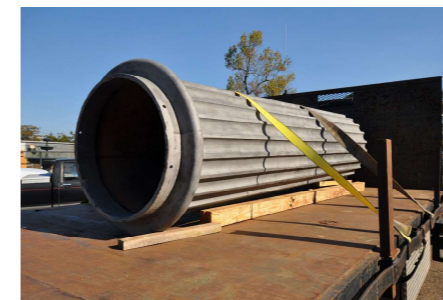
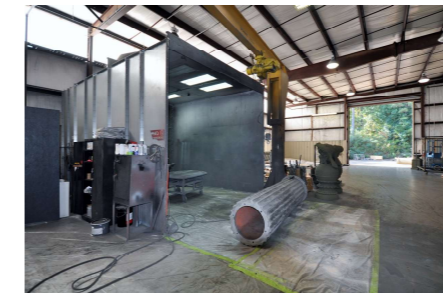
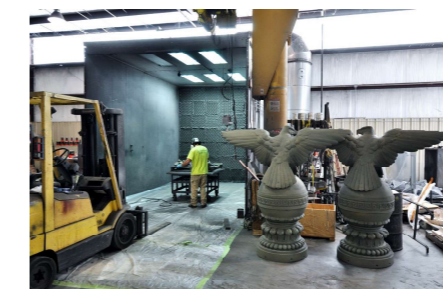
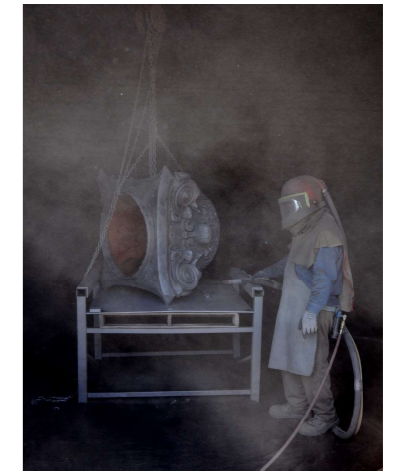
ROBINSON IRON WORKS

At Robinson Iron's shop the various elements are broken down to logical subassemblies, sandblasted to white metal and immediately coated with a zinc rich primer. This is followed by a white epoxy coat and a black fluoropolymer top coat. Some elements require repair and a number of our assemblies (above) will need to be recast. So far most elements have been found to be in excellent condition.
